Journal of Mechanics of Materials and Structures

**MECHANICS OF FLYING BUTTRESSES:
THE CASE OF THE CATHEDRAL OF MALLORCA**

Volume 13, No. 5

December 2018

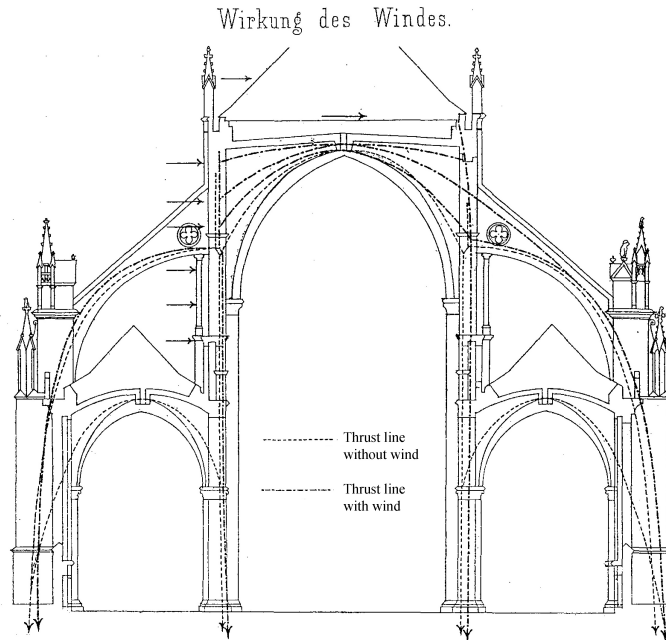
Figure 1. Cross section of the cathedral of Strasbourg showing the thrust line with and without wind [Ungewitter 1890]. Dotted line: thrust line without wind. Dotted-dashed line: thrust line with wind. Note that, with wind, the thrust line goes through the wall over the transverse arches.

The first complete static analysis was carried out by Mohrmann for the third edition of Ungewitter [1890], applying graphic analysis to the study of Gothic buildings, including flying buttresses (Figure 1). He differentiated between the function of lower and upper flyers, assigning the upper ones the function of taking the wind load. The contributions of Mohrmann were known in the United Kingdom through the work of Rosenberg [1936]. Fitchen [1955] further discussed the function of the upper flying buttresses.

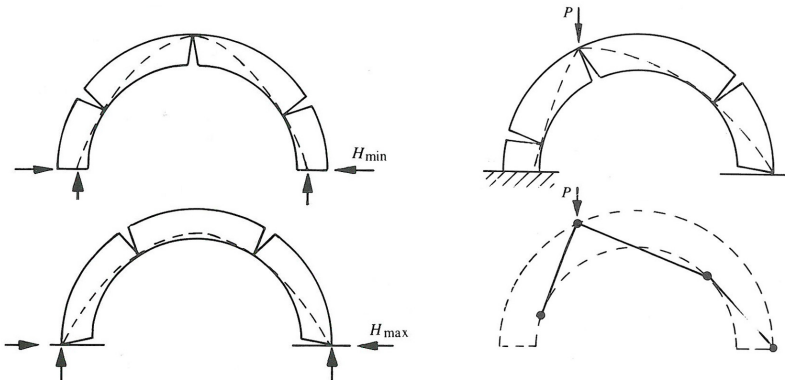
Figure 2. Semicircular arch: line of minimum thrust and line of maximum thrust (left column) and collapse mechanism (right column) [Heyman 1995].

and the arch has to accommodate to the new span with the formation of the three hinges shown in Figure 2 (left top). If a fourth hinge is formed, the structure will turn into a mechanism (Figure 2, right column).

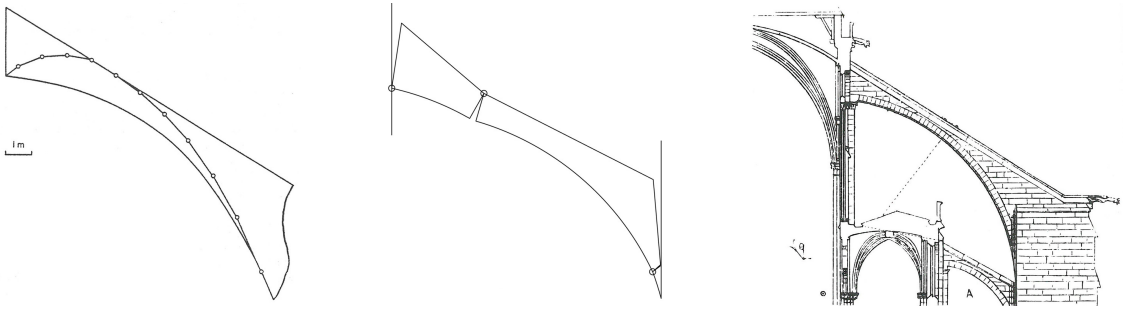
Figure 3. Left: passive line of thrust in the flying buttress of Nôtre-Dame, Paris [Heyman 1966]. Center: flying buttress of Nôtre-Dame with a spreading of the abutments. Right: partial cross-section of Nôtre-Dame [Viollet-le-Duc 1854].

In the case of flying buttresses, the line of minimum thrust is shown in Figure 3 (left) for the long flyer of Nôtre-Dame, Paris. The mechanism of three hinges formed by the spreading of the abutments is shown in Figure 3 (center).

Master masons were aware of the sliding problem and they took measures to avoid it. The common solution in French Gothic was placing a column or a pilaster under the head of the buttress (Figure 3, right). In the case of Mallorca, as will be seen, master masons used a solution unique in Gothic construction, placing stone bracings under the head to avoid this sliding. It is also possible to avoid the sliding by varying the form of the flyer, as remarked by Heyman [1966, p. 264] in the case of Lichfield cathedral (Figure 6), where the thinness and slope of the flyer causes an almost horizontal thrust at its head.

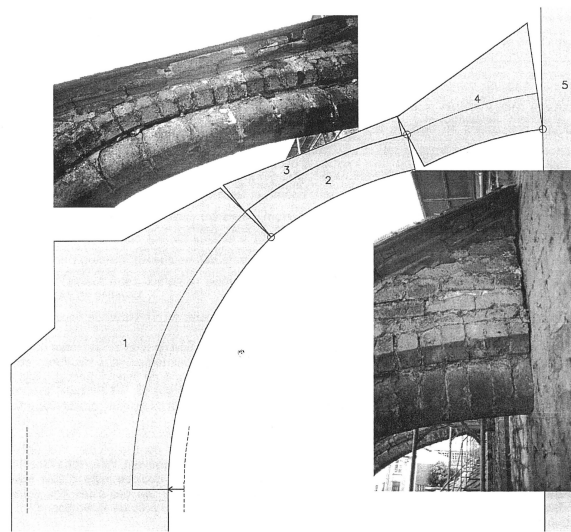
Figure 4. Cracking forming three hinges in a flying buttress at the Dominican church of Louvain [Smars 2000].

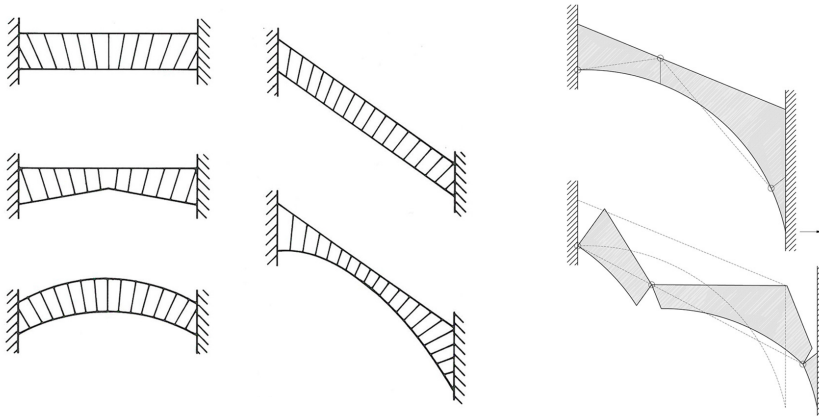
Figure 5. First and second column: arches that cannot collapse by the formation of a four hinge mechanism [Heyman 1995]. Third column: snap-through mechanism for a flying buttress.

As Heyman pointed out, for some arch geometries it is not possible to find a mechanism of collapse. This is the case of flat arches, and most flying buttresses, which are a development on the flat arch (Figure 5, first and second column) [Heyman 1995, p. 20]. Considering infinite compressive strength, these arches will only collapse if the abutments spread enough to form a *snap-through* mechanism that requires very large displacements (Figure 5, third column).

The spreading that would cause the collapse of the flying buttresses shown in [Figure 5](#) (right column), would be 1.38 m in the upper flyer and 1.81 m in the lower flyer. These movements are far from the actual movement of the flyers, which show a maximum opening of 44.5 cm in the south flying buttress B4 ([Table 1](#)).

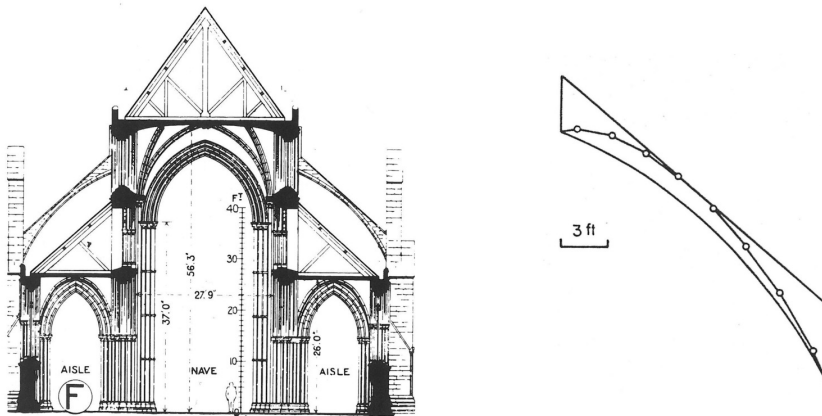
Figure 6. Left: Lichfield cathedral. Right: line of minimum thrust in the flying buttress at Lichfield cathedral; note the almost horizontal thrust at the head [Heyman 1966].

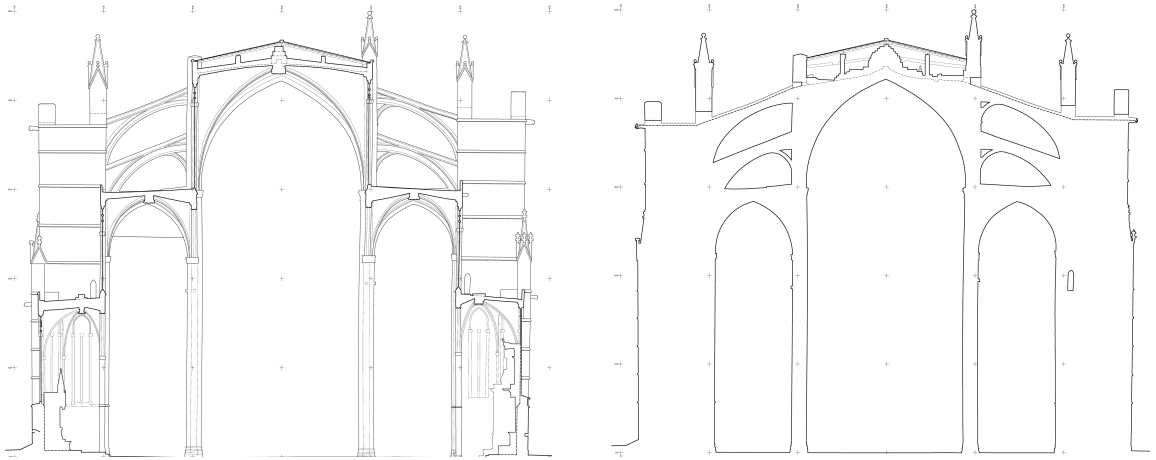
Figure 7. Cross-section of the cathedral of Mallorca: through the center of the fifth bay (left) and through the fifth pillars (right) [Fuentes and Guerra 2015].

The cathedral has the highest central nave in Spanish Gothic architecture, reaching 44 m. The span, approximately 18 m, is one of the longest and the pillars are some of the most slender found in a Gothic building (Figure 7). The construction of a building with these dimensions was for sure a structural challenge for the master builders.³ Flying buttresses are a fundamental element in the equilibrium of the building and their study is an important topic, since they have a considerable size (around 9 m span), and it is possible to observe deformations, sliding and original solutions responding to these problems.

It is worth discussing the presence of transverse walls over the transverse arches of the nave, connecting the upper flying buttresses found on either side (Figures 7 and 8). As Ungewitter [1890, p. 388] mentioned, the upper flyers do not benefit from the thrust of the vault to counteract their own thrust, and the construction of a transverse wall over the transverse arch between the both sides of the building increases their stability.⁴ Besides some construction differences, the shape of the flying buttresses is mainly the same in all different bays. The survey of the cathedral of Mallorca provided the possibility of studying the actual deformation of the flying buttresses and relate it to the leaning of the buttresses.⁵

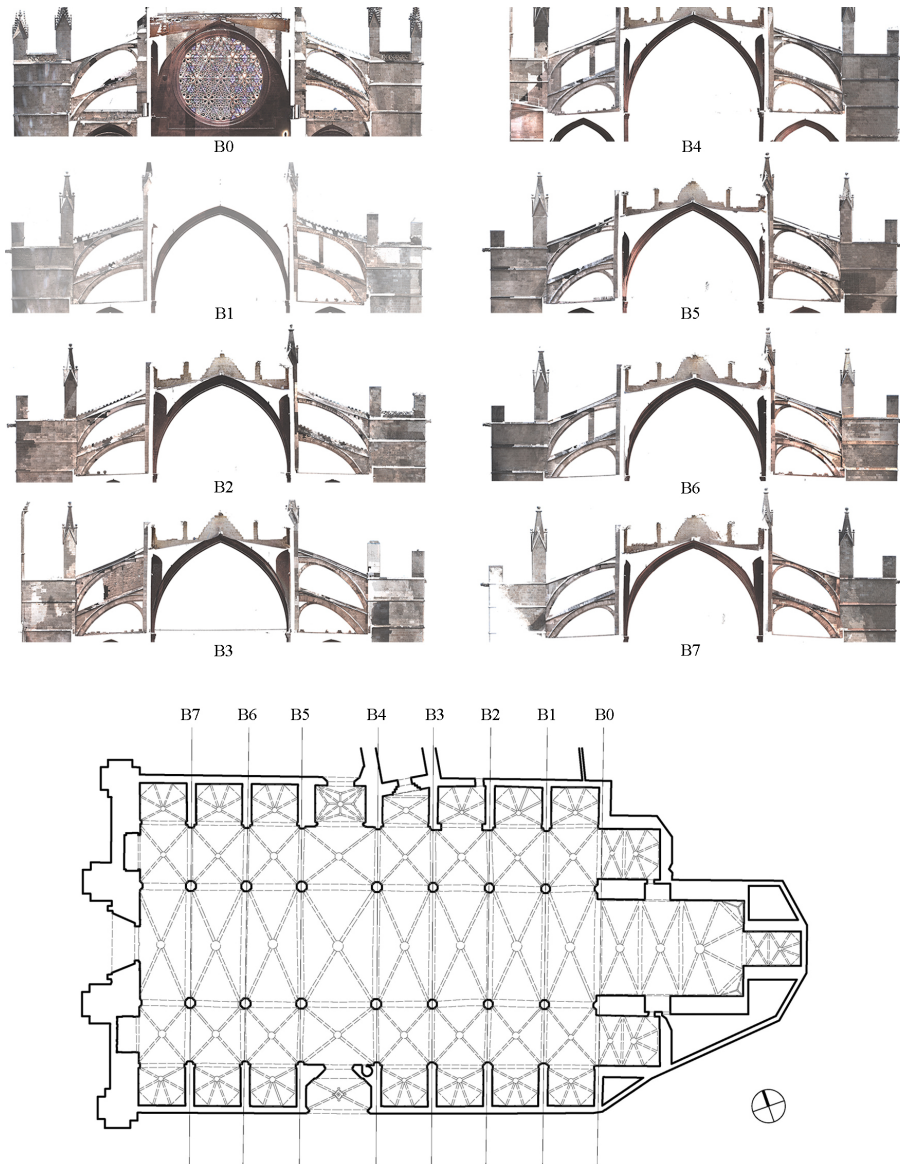
Figure 8. Elevations of all the flying buttresses (with the exception of the ones on the façade) and plan view of the cathedral of Mallorca (based on the cloud of points by Rex Haberland).

Table 1. Out of plumb of the external buttresses of the different porticos, on the north and south elevations (see plan in Figure 8). The buttresses lean always outwards from the nave, leading to an increased span for the flying buttresses. The table gives the out of plumb at two heights: 27.3 m and 34.7 m above the floor (table made after [Fuentes and Guerra 2016]).

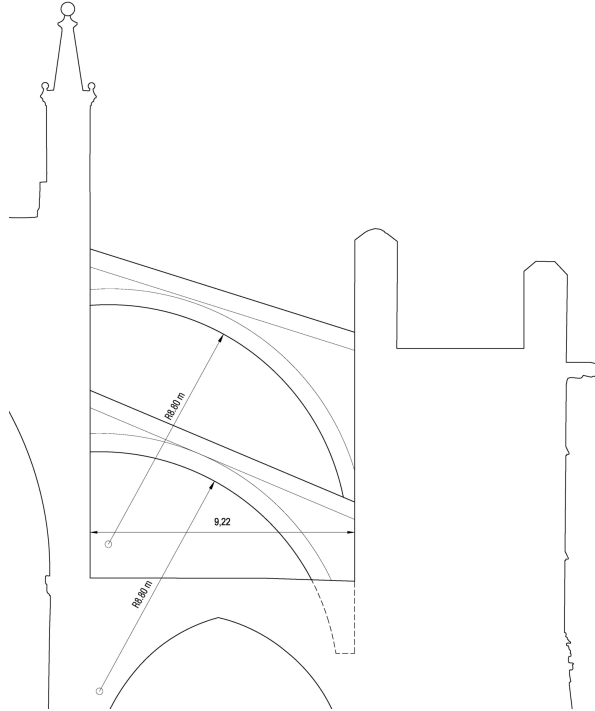
Figure 9. Ideal geometry considered for the structural analysis.

Based on the survey, the original shape of the flyers has been supposed as shown in Figure 9. This ideal geometry is based on the fourth flying buttress of the north side, where the presence of the tower has prevented large deformations. A radius of 8.8 m fits very well with the survey.

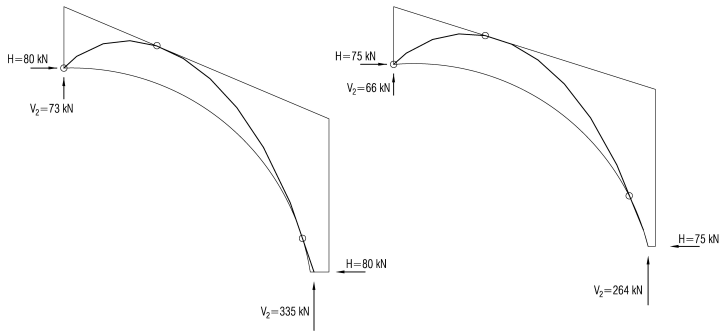
Figure 10. Line of minimum thrust: lower flying buttress (left) and upper flying buttress (right).

For the present analysis of the flying buttresses, a specific weight of 18 kN/m^3 has been assumed.⁶ The lower flyer has been calculated to have a weight of 408 kN. The passive thrust is 80 kN. The upper flying buttress has a smaller passive thrust of 75 kN and a weight of 330 kN (Figure 10).

2.3. Prevention of sliding. As discussed in [Section 1](#), the flying buttresses of Mallorca are not connected to the nave wall. Therefore, sliding may occur for the line of minimum thrust. Note that the thrust against the wall in the lower flyers forms an angle of 42.4° , while in the upper flyers it is of 41.4° ([Figure 10](#)).

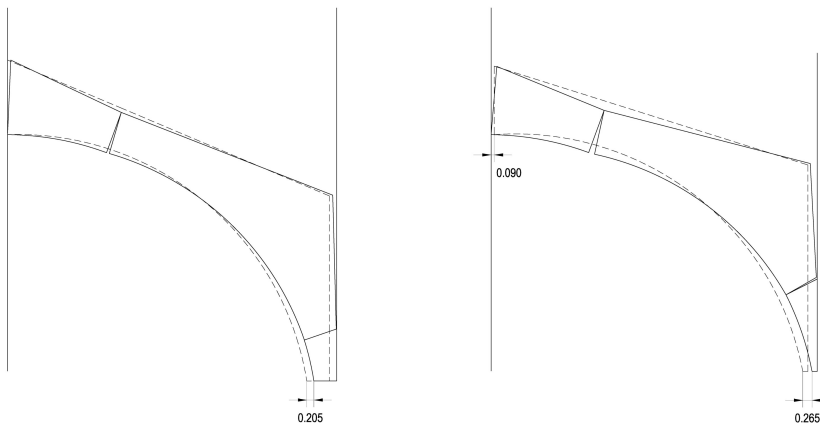
Figure 11. Theoretical deformation of the ideal flying buttress for the leaning of the south buttress B1 and the leaning of the nave wall. Geometry previous the deformation in dashed line: lower flying buttress (left) and upper flying buttress (right).

the lower flyers) and the inwards leaning of the nave wall (9 cm). For these deformations, the maximum drop is 18 cm in the lower flyer and 27 cm in the upper flyer (Figure 11).

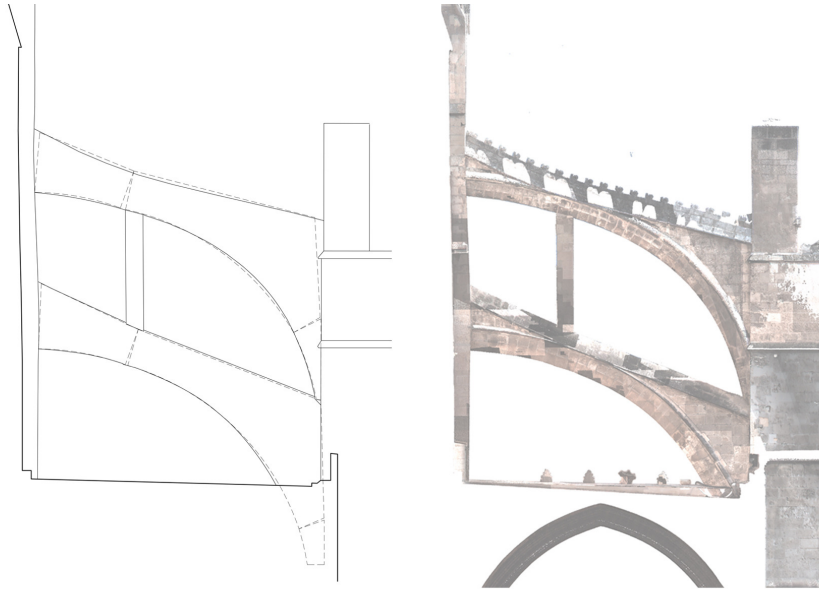
Figure 12. Comparison of the theoretical deformation (dashed line) with the real deformation (continuous line) (left) and orthophoto of the south flying buttresses B1 (right) (based on the point cloud by Rex Haberland).

Comparing the theoretical deformation with the survey, the maximum deviation measured in the lower flying buttress is 6 cm in the lower part and around 8 cm in the upper flyer, at the point of the upper crack. Despite these differences, the general form of the theoretical deformation agrees with the survey (Figure 12). Despite the deformations being visible, cracks have probably been filled in restoration works along the centuries and are not evident.

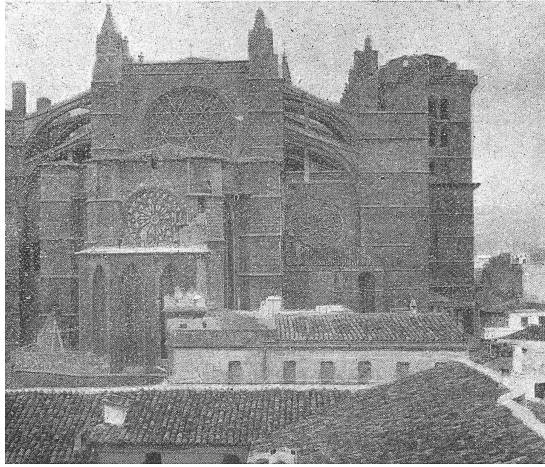
Figure 13. Exterior view of the cathedral of Mallorca from the east. Note the two pillars in the north flying buttresses and another one under the lower south flying buttress [Rubió i Bellver 1912].

Pillars between the two flying buttresses are currently present in 4 of the 16 pairs. However, looking at historical photographs it is possible to verify that at least three more pillars were found in the first two pairs of flyers, close to the apse, with two under the lower flying buttress and another one between the lower and the upper flying buttresses ([Figure 13](#)). At some point, these pillars were removed, probably because they were the only three visible from the ground.¹⁰

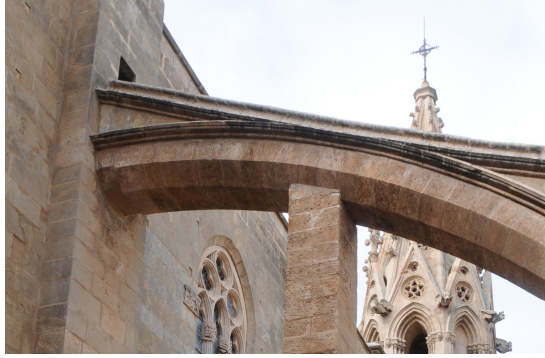
Figure 14. Sliding in the upper flying buttress B6N. Note that the sliding is not between the wall and the first voussoir, but between first and second voussoirs [Photo: Roland Wiczorek, BTU Cottbus-Senftenberg].

As in the upper flying buttresses there is no thrust to counteract, their state is that of minimum thrust or close to it, and since they are in the limit of possible sliding, some of them present this problem while others do not. This difference most likely depends on small variations of the thrust or on the contact surface, as small irregularities on the surface can increase the friction coefficient.

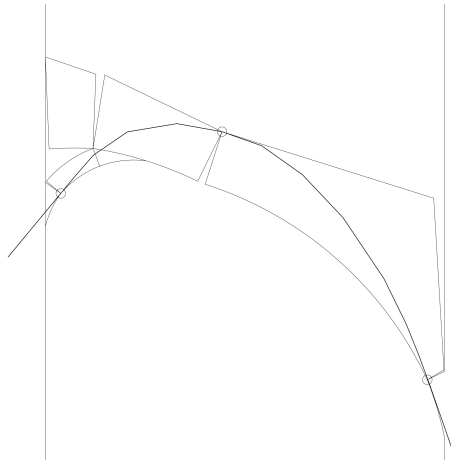
Figure 15. Line of minimum thrust for the flying buttress with the insertion of bracing.

Probably aware of the sliding problem, experts in the 17th and 18th centuries recommended the construction of bracing in the flyers [Domenge and Conejo 2003, p. 12]. It is a completely original solution that has not been found in other Gothic buildings ([Figure 8](#) and [Figure 16](#)). The bracing solved the problem, but resulted in unexpected distortions. The effect is shown in [Figure 15](#). When the span increases, three hinges appear in the flyer, one on the intrados at the springing, another one on the extrados close to the midpoint, and the third one in the bracing. When the bracing rotates, the space for the voussoirs between the bracing and the wall increases. As a result, the voussoirs slide and descend. However, further movements are constrained by the bracing itself. This causes a particular shape with double curvature in the upper part of the flying buttress, visible in some of them ([Figure 16](#)).

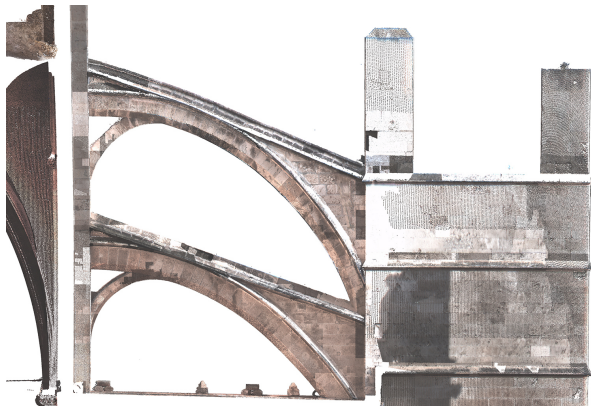
Figure 16. Orthophoto of south flying buttresses B1 (based on the cloud of points by Rex Haberland).

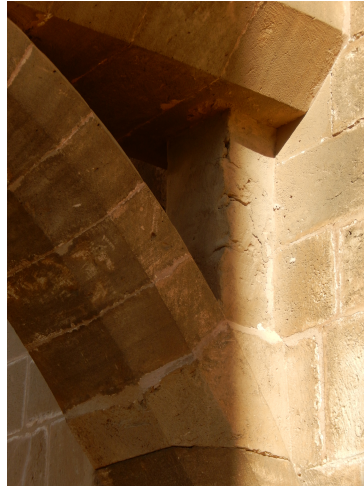
Figure 17. Small stud between the lower flying buttress and the support in B6S (photo: Huerta 2016).

The master mason probably noticed this effect and tried to correct it with a small stone strut between the flying buttress and the bracing, as can be seen in [Figure 17](#).
